Asbestos Inspection Report

5883 Ames Road
Columbia, South Carolina

ARM Project No. 09-1065-09

ARM ENVIRONMENTAL
SERVICES, INC.

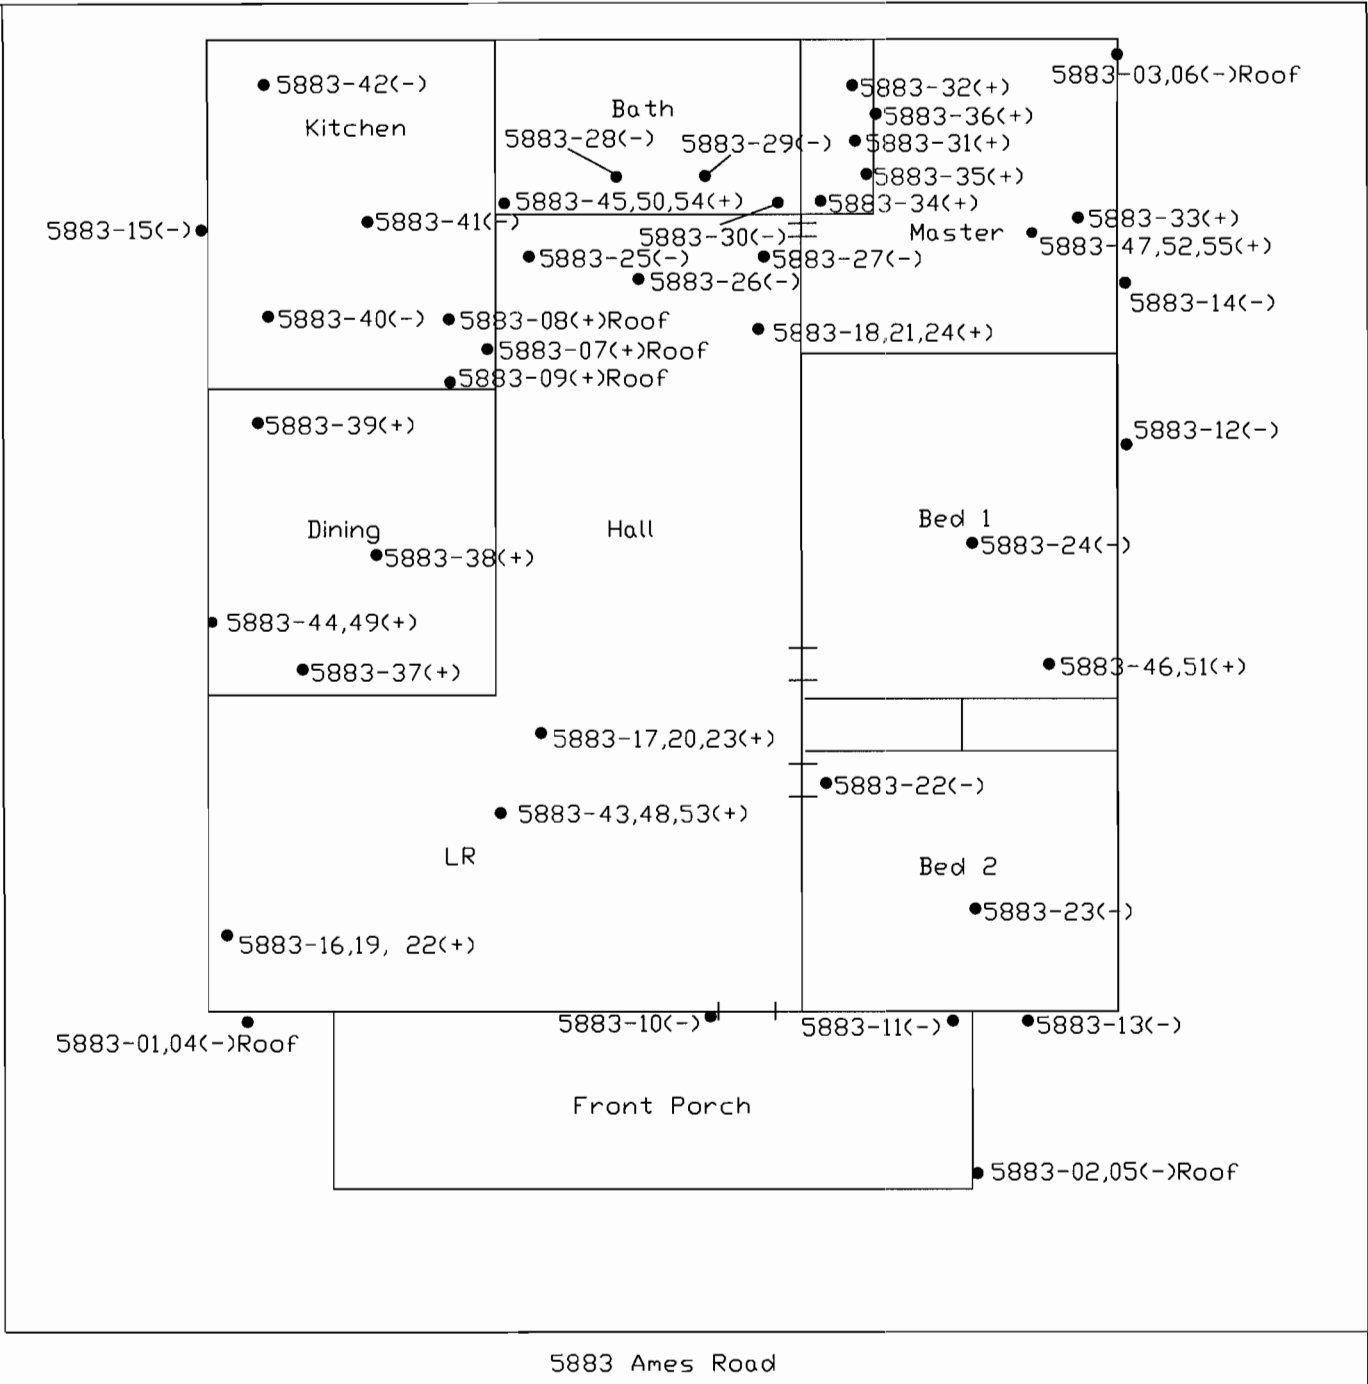
Laboratory analysis for the subject building indicate that asbestos was found in the sealant tar on the roof, the vinyl sheet flooring materials in the living room, hallway, all bedrooms, bathroom and dining room, and the joint compound in the drywall ceiling.

In the present condition, there is a low potential for significant concentrations of asbestos fibers to be released into the air from these non-friable category I asbestos materials. It is recommended that a licensed asbestos abatement contractor conduct or supervise the removal and proper disposal of these materials prior to demolition of this building.

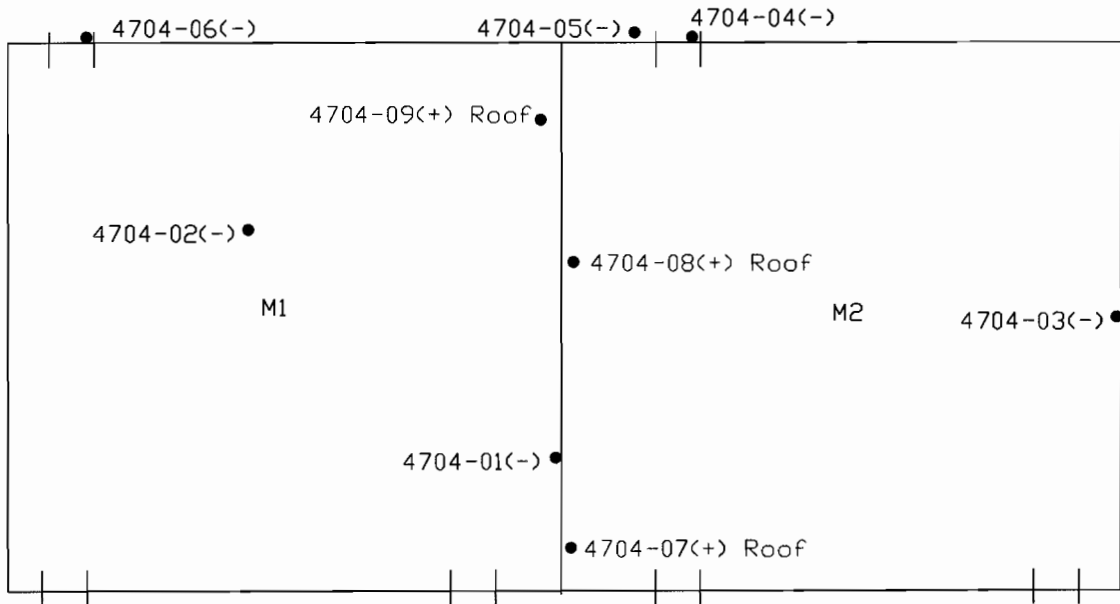
4704 Colonial Drive

Laboratory analysis for the subject building indicates that asbestos was found in the sealant tar covering the expansion joint at the center of the roof.

In its present condition, there is a low potential for significant concentrations of asbestos fibers to be released into the air from this non-friable category I asbestos material. It is recommended that a licensed asbestos abatement contractor conduct or supervise the removal and proper disposal of this material prior to demolition of this building.

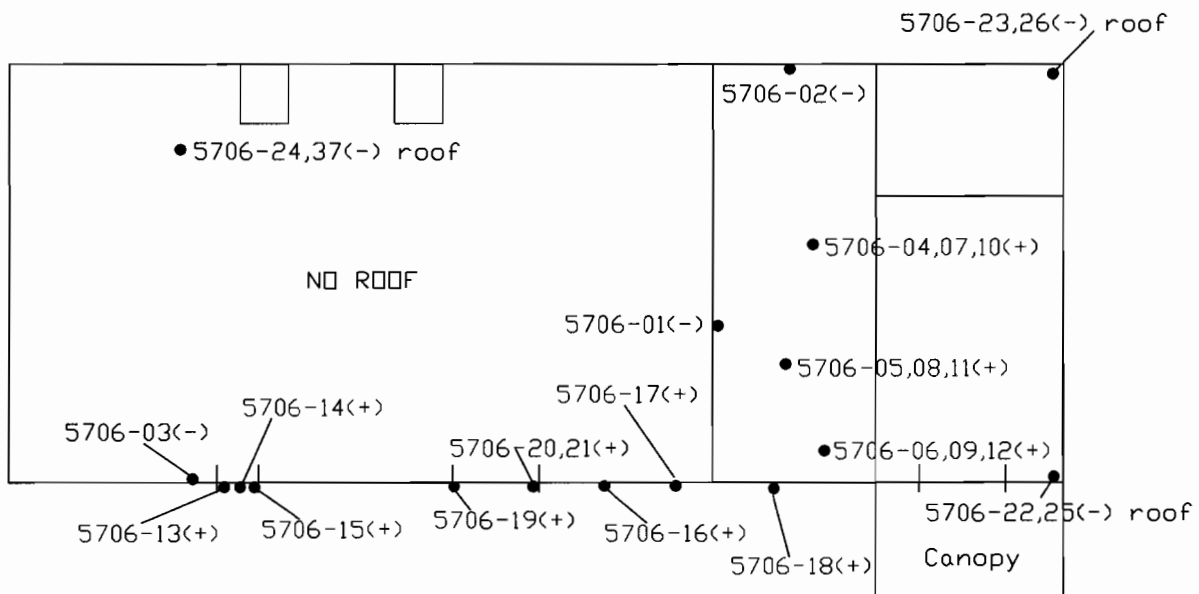
5706 Farrow Road

Laboratory analysis for the subject building indicates that asbestos was found in the joint compound associated with the drywall ceiling system, the glaze on a rear door window and the frame caulk around windows and doors.

In the present condition, there is a high potential for asbestos fibers to be released from these friable asbestos materials. State and Federal regulations require the removal of this material by a licensed DHEC asbestos abatement contractor prior to any disturbance caused by renovation or demolition.

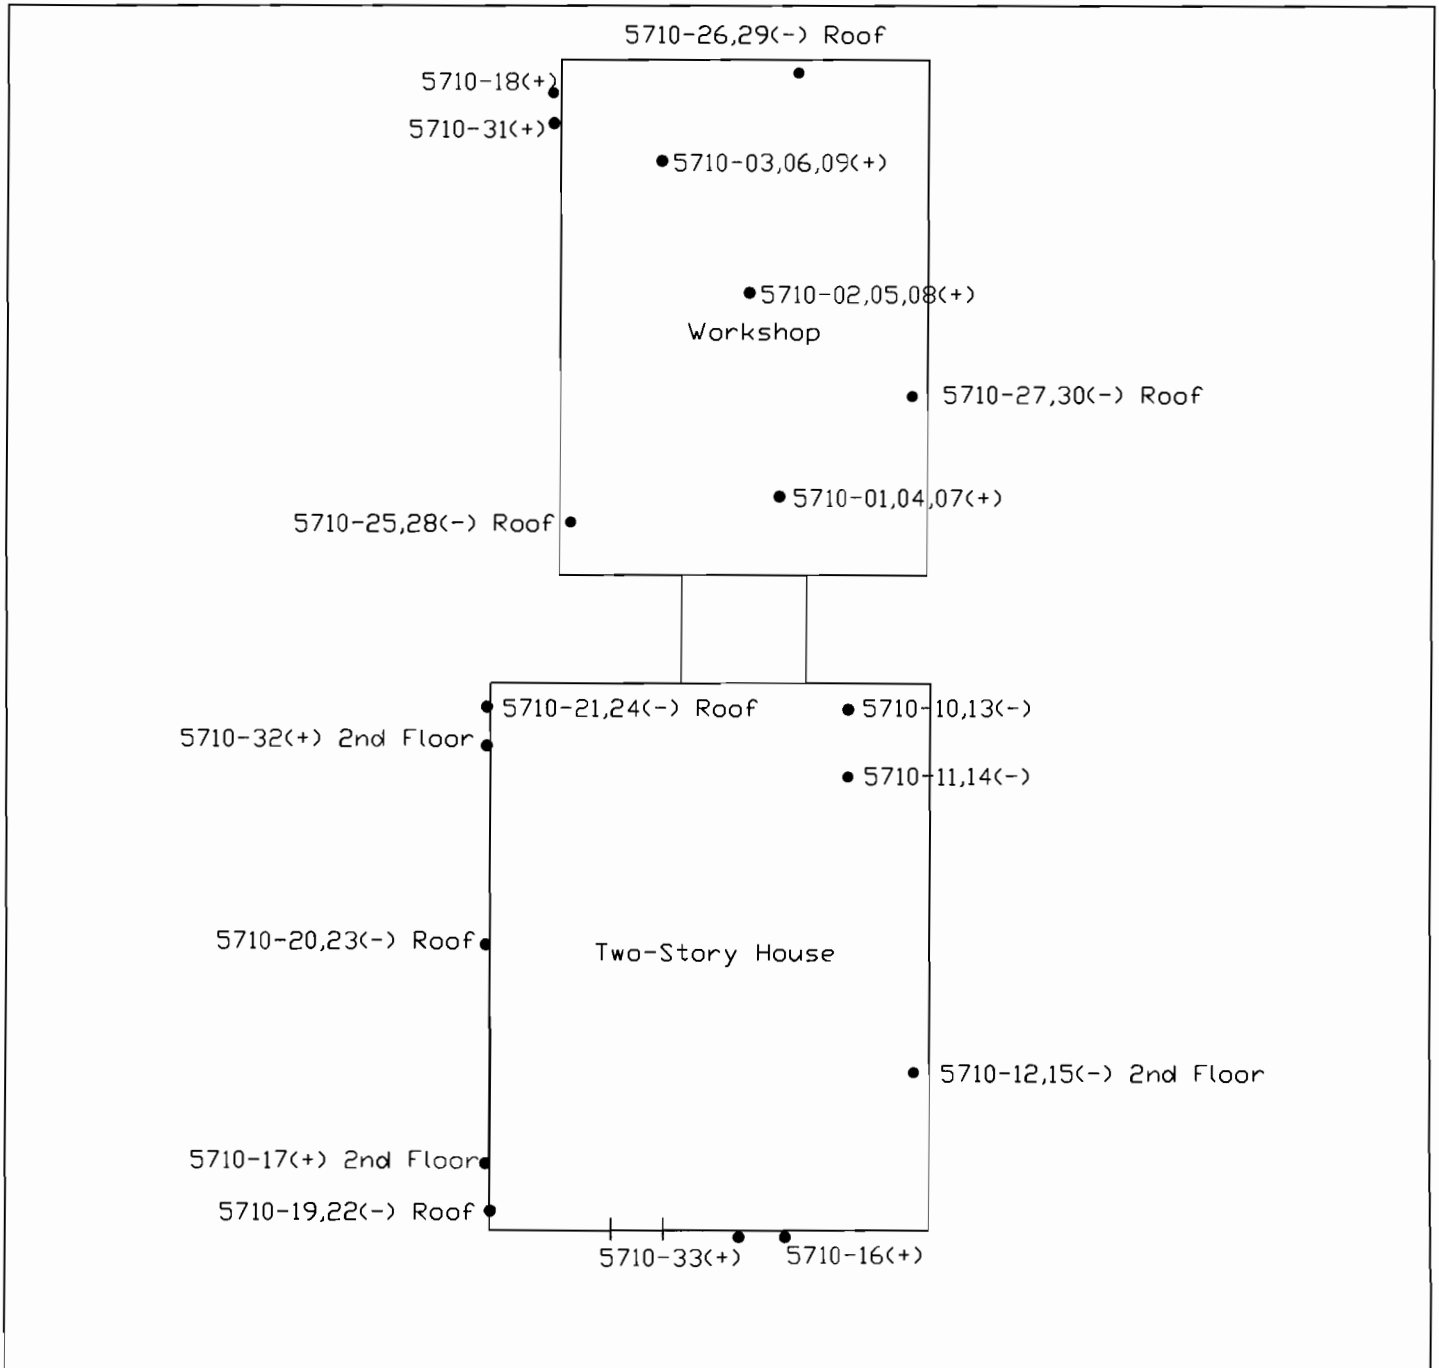
5710 Farrow Road

Laboratory analysis for the subject building indicates that asbestos was found in the textured ceiling materials in the workshop portion of the structure, all exterior window glaze and frame caulk.

The drywall ceiling panels and associated joint compound materials are contaminated by the asbestos textured ceiling materials found in the workshop portion of this structure, and must be treated as an ACBM.
