**ASBESTOS CONTAINING MATERIAL (ACM)
AND
LEAD BASE PAINT (LBP) SURVEY**

**724 AND 710 CROSS HILL ROAD
COLUMBIA, SOUTH CAROLINA**

2430 Greene Street
Columbia, South Carolina

1818 / 1820 Mitchell Street
Columbia, South Carolina

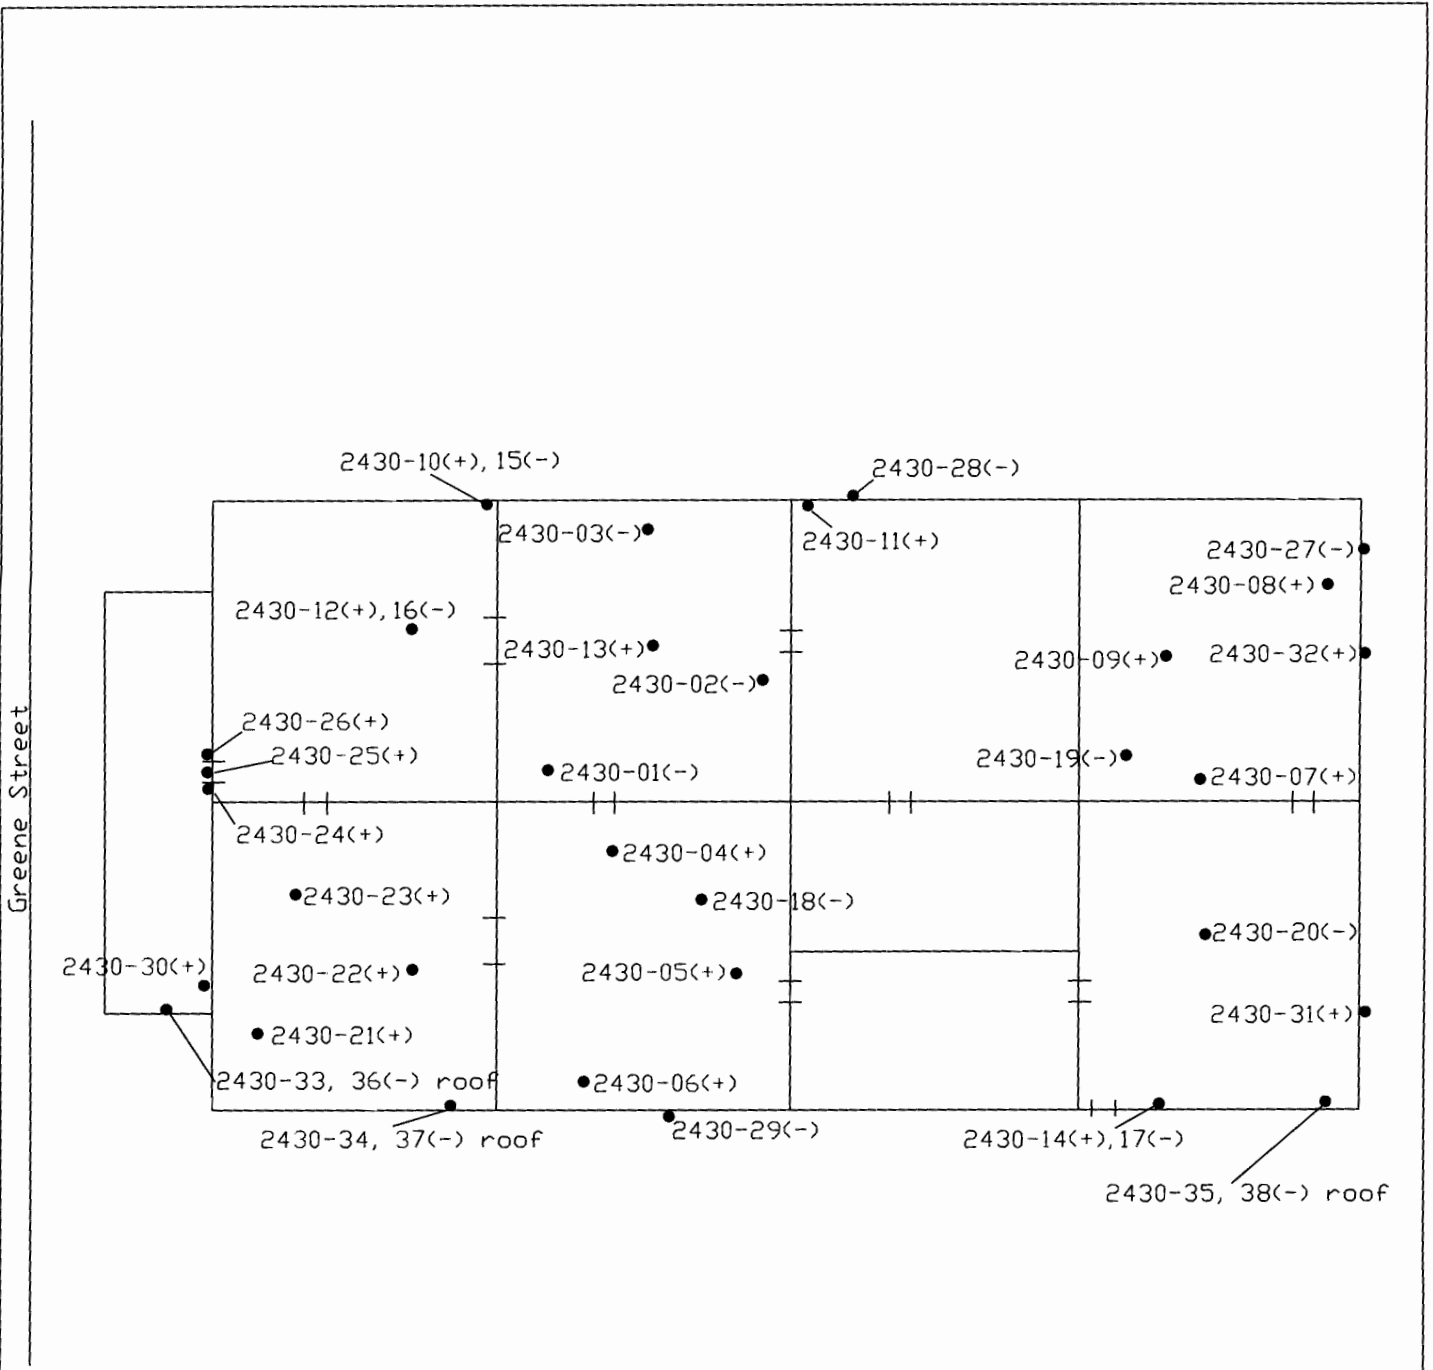
<p><i>PROJECT:</i></p> <p>Asbestos Survey 2430 Greene Street Columbia, South Carolina ARM #09-1065-09</p>	<p><i>DESCRIPTION:</i></p> <p>Sample Location Map</p>	<p style="text-align: center;">FIGURE 1</p> <p><i>DATE:</i> November 2009</p>

Laboratory analysis for the subject building indicate that asbestos was found in the brown sheet flooring located in the kitchen (between plywood sub-floors), the twelve inch by twelve inch white floor tile located in the HVAC room at the rear of the house, the joint compound associated with drywall walls and ceiling, the troweled-on ceiling finish located in the den, the frame caulk around the front door and sealant tar located on the roof around the chimney.

In the present condition, there is a high potential for asbestos fibers to be released from these friable asbestos materials. State and Federal regulations require the removal of this material by a licensed DHEC asbestos abatement contractor prior to any disturbance caused by renovation or demolition.

In the present condition, there is a low potential for significant concentrations of asbestos fibers to be released into the air from these non-friable category I asbestos materials. It is recommended that a licensed asbestos abatement contractor conduct or supervise the removal and proper disposal of these materials prior to demolition of this building.

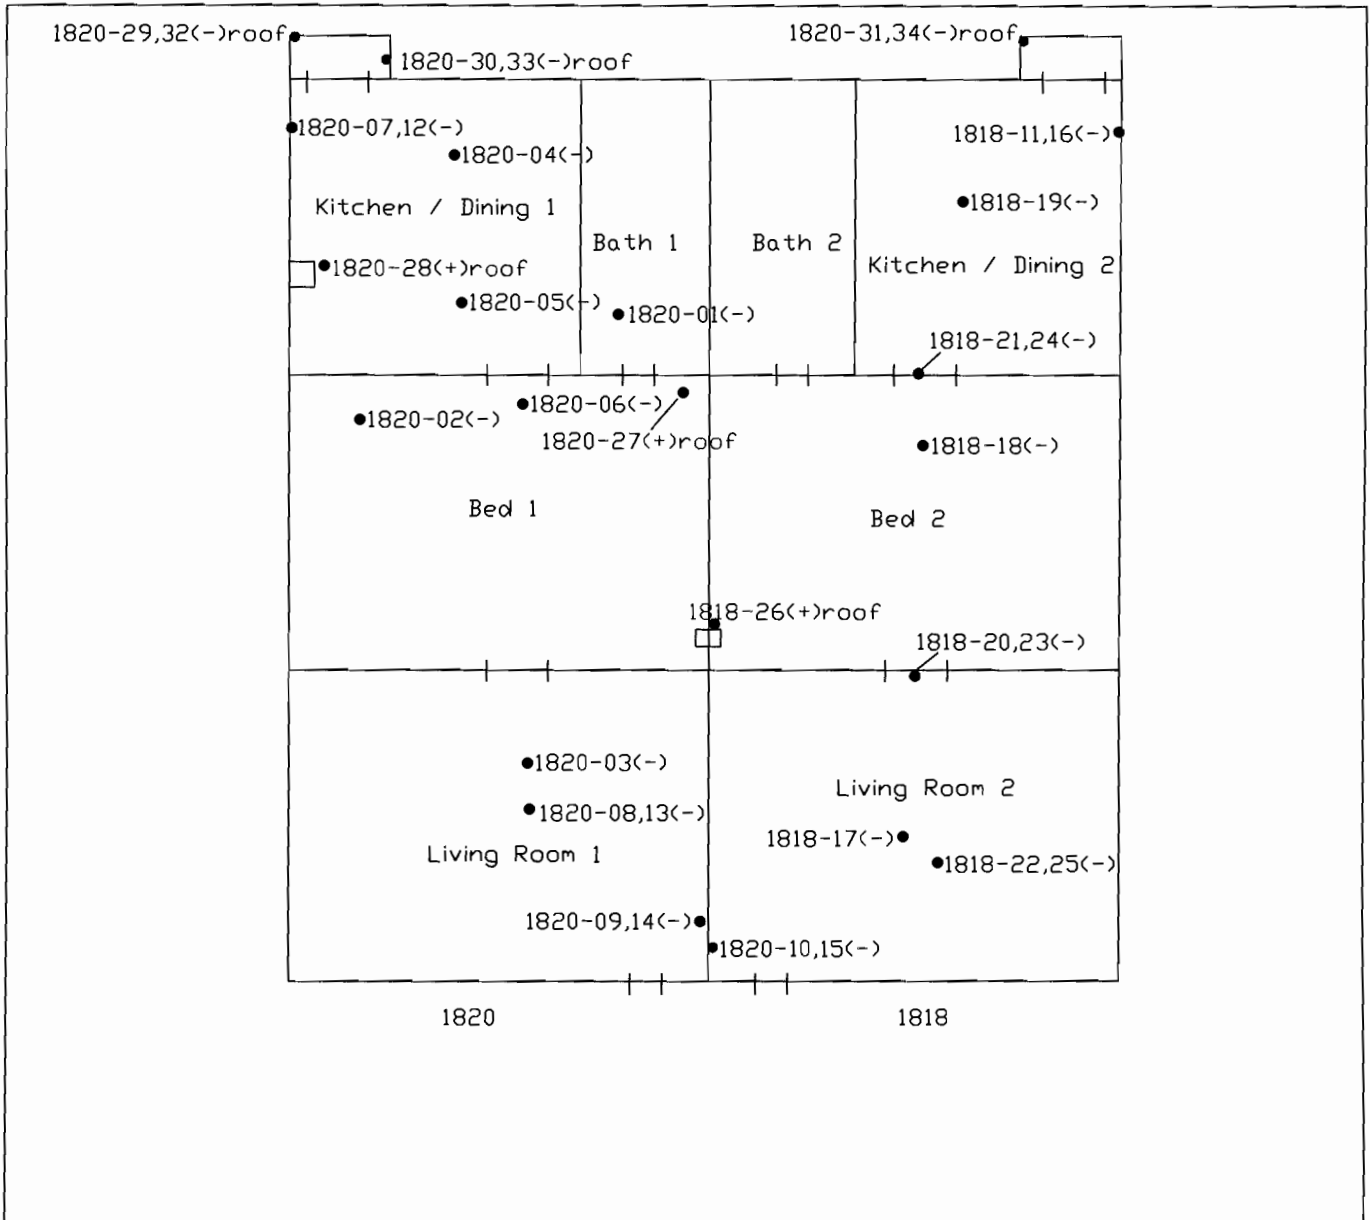
1818/1820 Mitchell

Laboratory analysis for the subject building indicate that asbestos was found in the roof sealant material coating the metal panel roofing on the structure.

In its present condition, there is a low potential for significant concentrations of asbestos fibers to be released into the air from this non-friable category I asbestos material. It is recommended that a licensed asbestos abatement contractor conduct or supervise the removal and proper disposal of this material prior to demolition of this building.

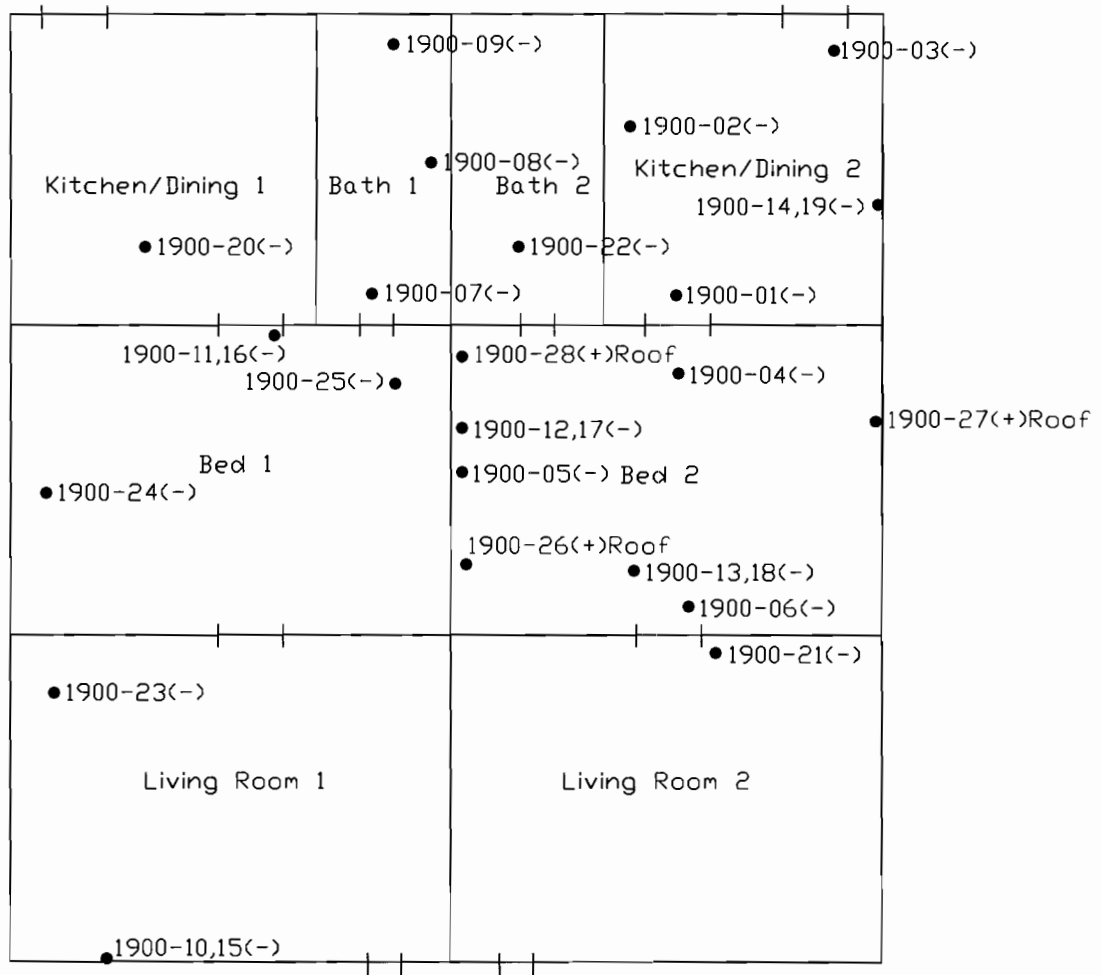
1900 Mitchell

Laboratory analysis for the subject building indicates that asbestos was found in the sealant tar located at one seam on the metal panel roof and around chimneys.

In its present condition, there is a low potential for significant concentrations of asbestos fibers to be released into the air from this non-friable category I asbestos material. It is recommended that a licensed asbestos abatement contractor conduct or supervise the removal and proper disposal of this material prior to demolition of this building.

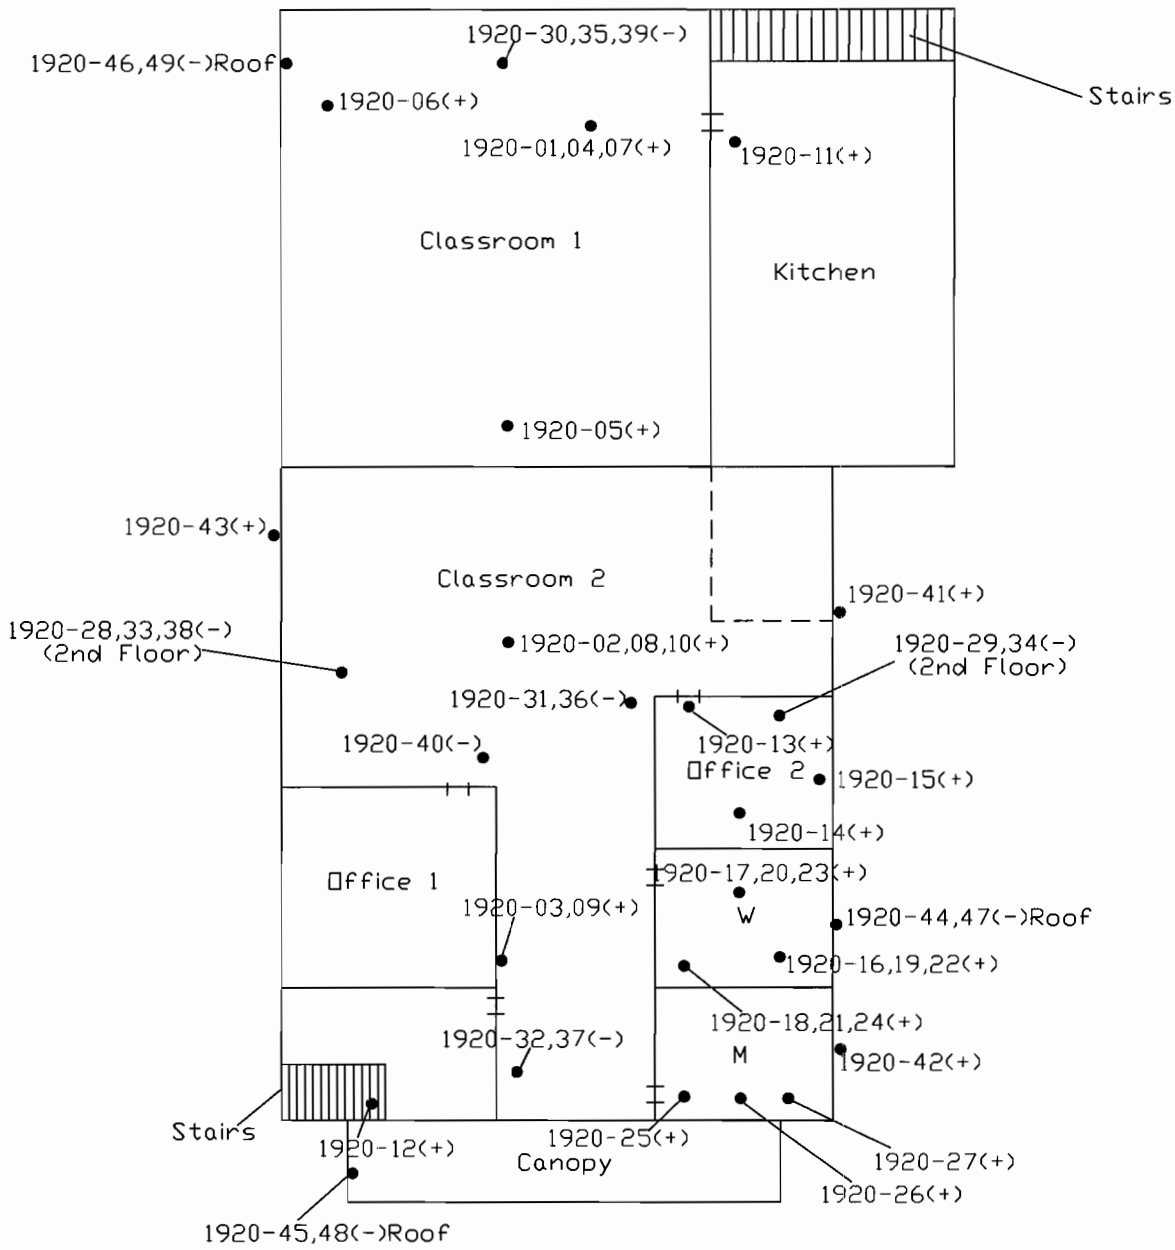
1918/1920 Mitchell

Laboratory analysis for the subject building indicate that asbestos was found in the bottom layer of floor tile mastic and bottom paint layer under all vinyl flooring materials, leveling compound and floor glues located on the ground level. The floor tile mastic and bottom paint layer are tightly bound with the vinyl flooring materials, leveling compound and floor glues, therefore contaminating these materials.
