## D/DRC Case

1008 Laurens Street

University Hill Architectural Conservation District

**DESIGN/DEVELOPMENT REVIEW COMMISSION**  
**DESIGN REVIEW DISTRICT**  
**HISTORIC REGULAR AGENDA**  
**EVALUATION SHEET**  
**Case #3**

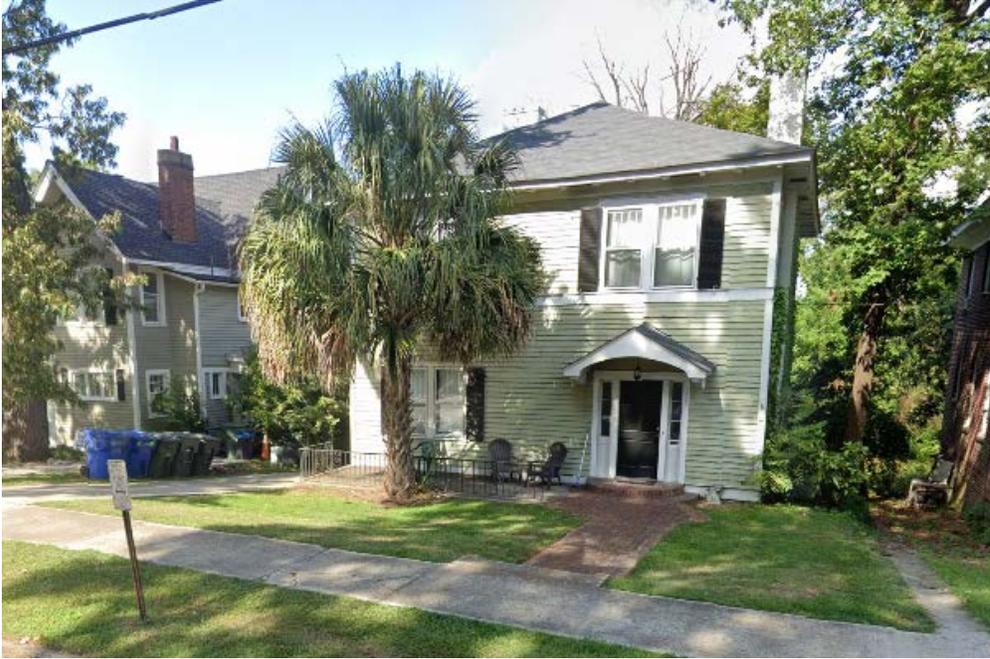
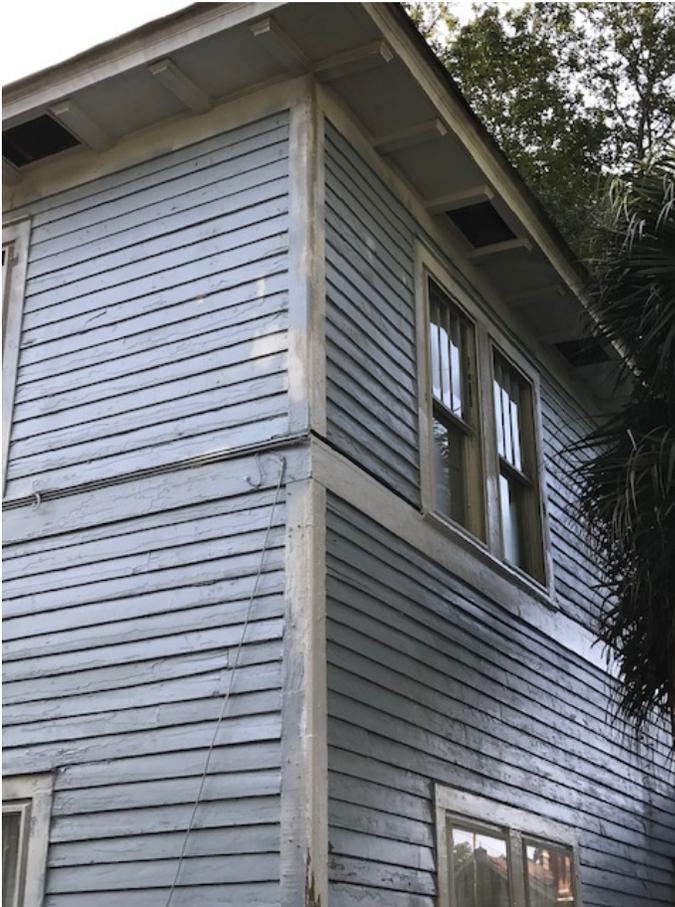
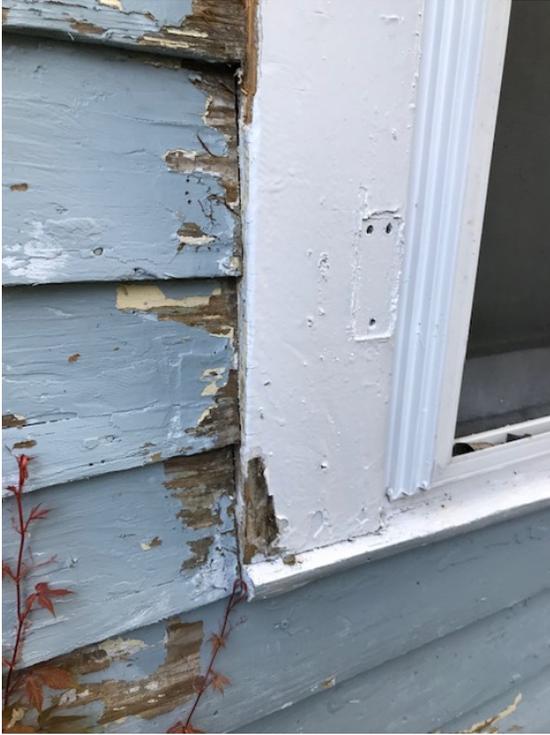
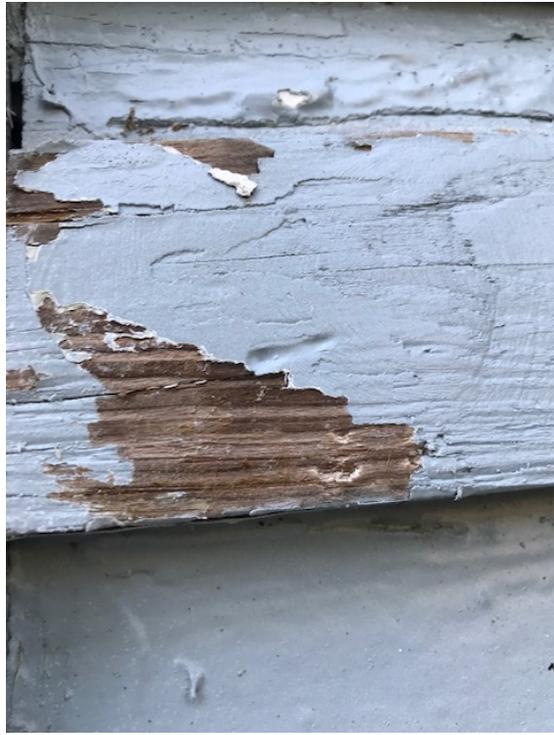
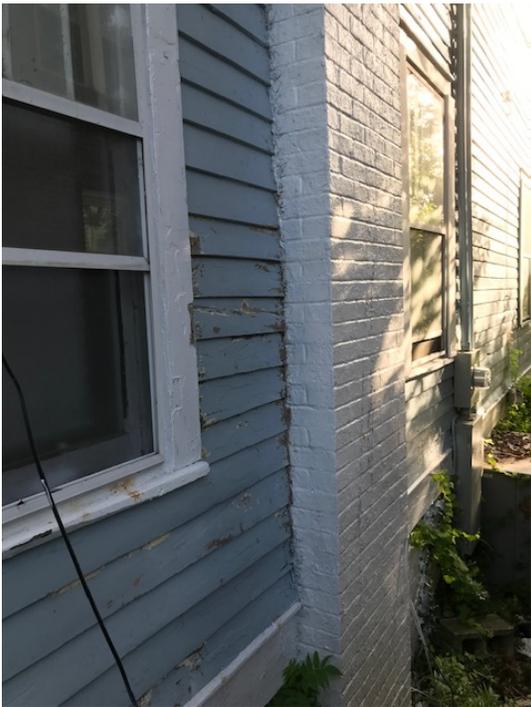
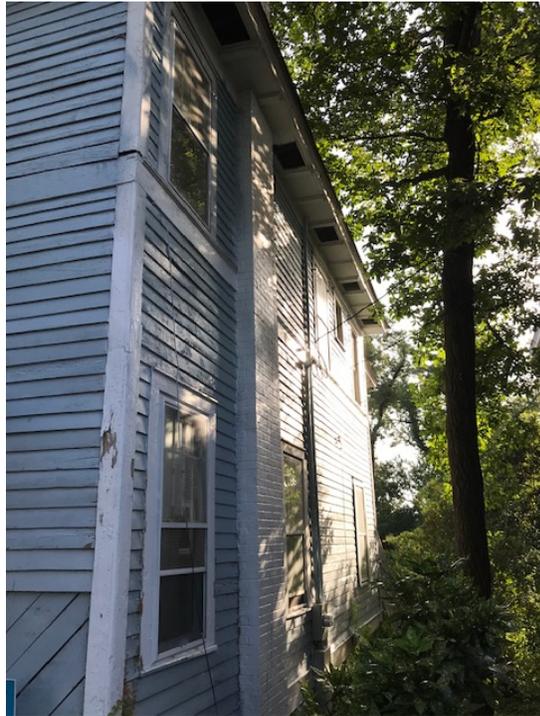
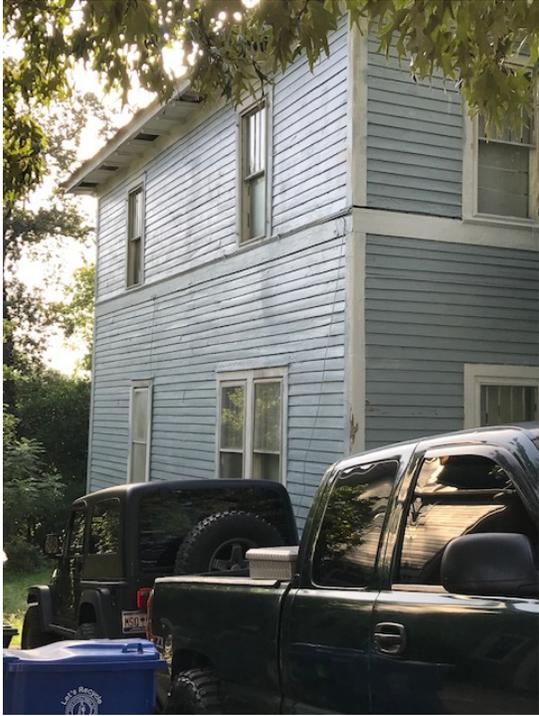
Paint: Regarding the issue of getting paint to stick, staff agrees that the multiple layers of paint are probably an issue. One sees this frequently with older structures. Up close photos show the many layers of paint which have been applied; it appears that care has not been taken to spot sand as needed over the years to maintain an even base coat upon which to re-paint, an unfortunate practice which is not uncommon. The contractor has said they have

tried sandblasting (not recommended for historic structures) and using a metal grinder to remove paint without success; and of course painting on top of these layers of paint will not be successful. One generally has to sand down to a smooth surface to prime and repaint for a coat that will hold or else remove paint to get down to the wood. This has to be done carefully and with the right tools so that the wood is not damaged. There are some tools recommended by preservation specialists for removing layers of paint; these tools are recommended as fairly quick-acting and effective and do not employ metal grinders or sandblasters. Staff has not seen any evidence that the underlying wood is causing an issue; however, if stripping down to the bare wood is desired, that is an excellent time to apply linseed oil to nourish the wood which would also extend the life of the paint job. Older wood such as this is so dense that it will repel insects and moisture if kept protected. Adequate care can ensure another 100 years for this siding.

This is a house that relies heavily upon its massing, materials, and simple details for its integrity. As can be seen in the pictures included in the evaluation, the window trim, sills, and so on, have a very shallow profile against the wood trim. Installing vinyl over the wood siding would effectively make these features disappear. Covering them over or removing them completely is in violation of the guidelines as well.

On this house some deteriorated wood has been replaced on the front of the structure with similarly profiled original wood from the back of the house; this meets the guideline. From a visual inspection of the front and sides, there does not seem to be a great deal of rot otherwise. Replacing or covering wood that is largely in good condition is not compatible with this guideline as the material is not deteriorated. Vinyl siding is also not an appropriate replacement material as it does not have the same reveal and width that one finds on original wood siding and where permitted (in other districts), is easily differentiated from wood when viewed from the public right-of-way.

Staff finds that the proposal to cover wood siding with vinyl siding at 1008 Laurens Street does not meet the University Hill Architectural Conservation District Guidelines, Section 8, Item 6, and recommends denial of the proposal.
